# **NATURAL FEATURES**

# Geologi Features

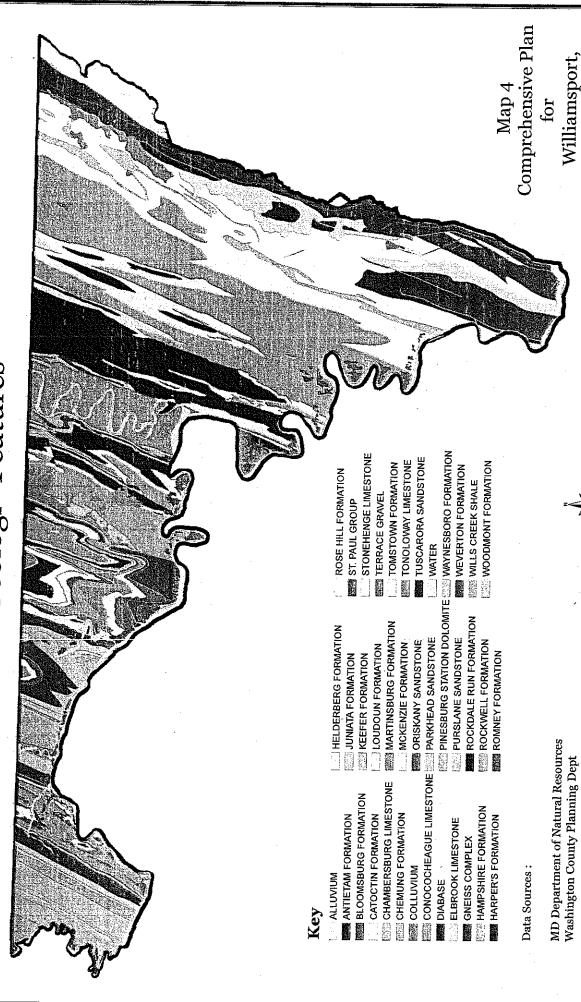
"The bedrock beneath the Town and its immediate vicinity consists of limestone and shale formed during the Ordovician Period, about 435 - 500 million years ago. A major fault line extends diagonally in a northeast-southwest direction through the extreme western portion of Williamsport (directly west of the intersection of Potomac and Conococheague Streets, and Frederick and Vermont Streets) separating the shale and limestone. Visually, this fault forms the ridge that extends along the eastern side of the Conococheage Creek and the Potomac River."

"Two different, but similar limestone formations occur in the territory east of this faultline. The older Stonehenge Limestone Formation adjoins this fault and occupies a band about one-third mile wide. This formation is estimated to be 500 to 800 feet thick. It contains massively bedded clayey limestone at its base and this conglomeratic beds in is upper portion."

"Immediately east of the Stonehenge Limestone lies a younger and harder limestone formation, the Rockdale Run Formation. This extensive formation occupies all the remaining portion of Williamsport, east of the faultline. Where the foil about the Rockdale Run Formation is more shallow, grading or excavation for foundations or utility lines is comparatively more expensive as it encounters this hard dolomitic limestone."

"The State's geologic map shows that the area west of this fault line contains Martinsburg Shale. This formation is found throughout Washington County, along the meandering sections of the Conococheague. In Williamsport, it underlies the area southeast of the confluence of the Conococheague Creek and the Potomac River. To the degree that its upper portion contains more shale than limestone or sandstone, it should be comparatively easier to grade or excavate than the limestone formations to the east."

"A final geologic feature influencing the Williamsport area is not really a formation, but has been caused by countless river terrace deposits in the area along the Potomac River flood plain. This deposit known as "Potomac River Alluvium," consists chiefly of brown, poorly-sorted, fine to medium sand and silt, with some gravel. This alluvium covers only the portion of Williamsport adjacent to the Potomac River and Conococheague Creek. Its depth to bedrock, near the Town, is reported to be from 21 to 27 feet."

<sup>&</sup>lt;sup>1</sup> Note - Reference is made to Map 4 - Geologic Features and Map 5 - Mineral Resource Geology
